U. F. COMBINED CYCLE POWER PLANT

REPARATION AND PROTECTION OF CONCRETE STRUCTURES (DECANTER) AND METAL MECHANICAL PARTS.

LOCATION: Combined Cycle Plant Aceca - Toledo - Spain.

FINALIZATION: April 2009.

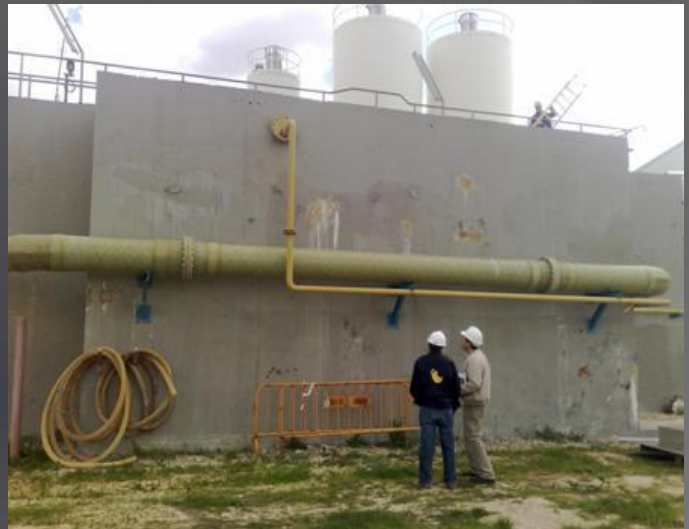
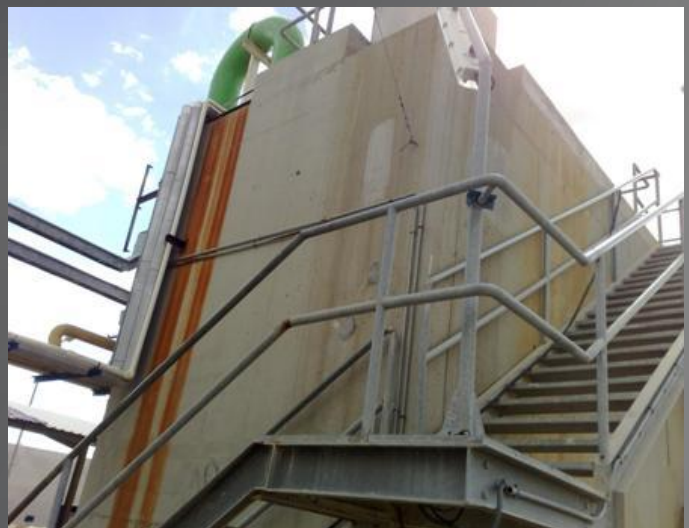
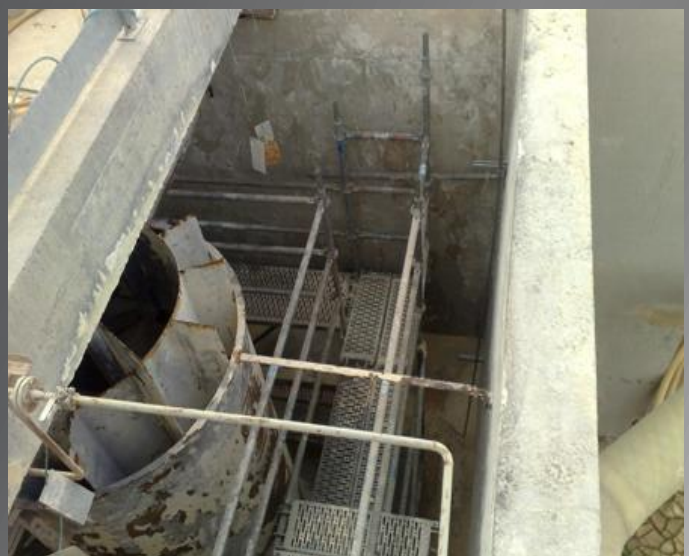
-The internal structure of the wall containing water chambers. An immediate solution was required for self-expel water from the outside of the decanter without damage the concrete structure.

Presence of metal mechanical parts inside the decanter with corrosion and deterioration

- The exterior structure of the decanter had leaks, damages of the concrete and deteriorations of the structure.

Reparation and protection of the interior and exterior of the structure of the decanter and the mechanical parts inside. (see bottom picture on the right).

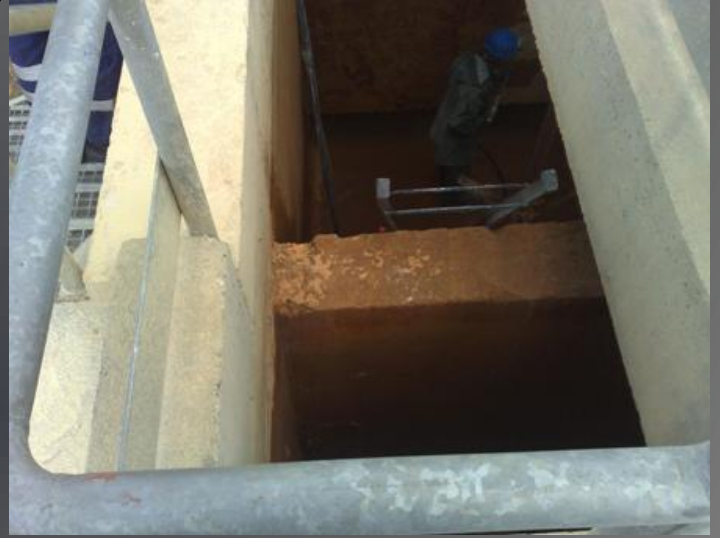
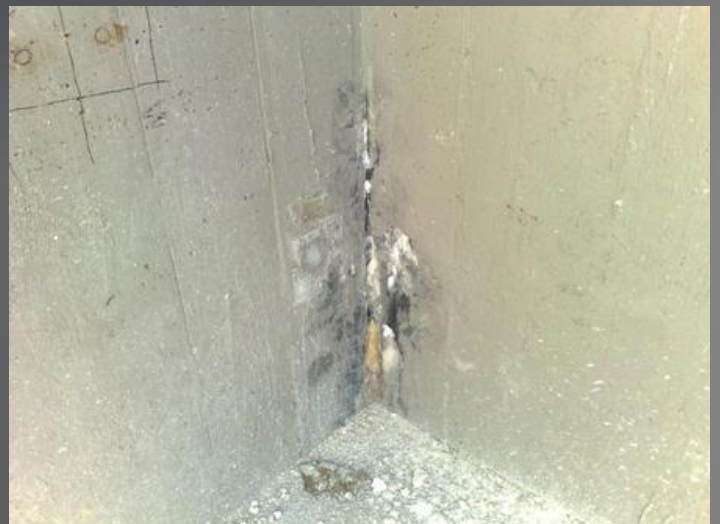
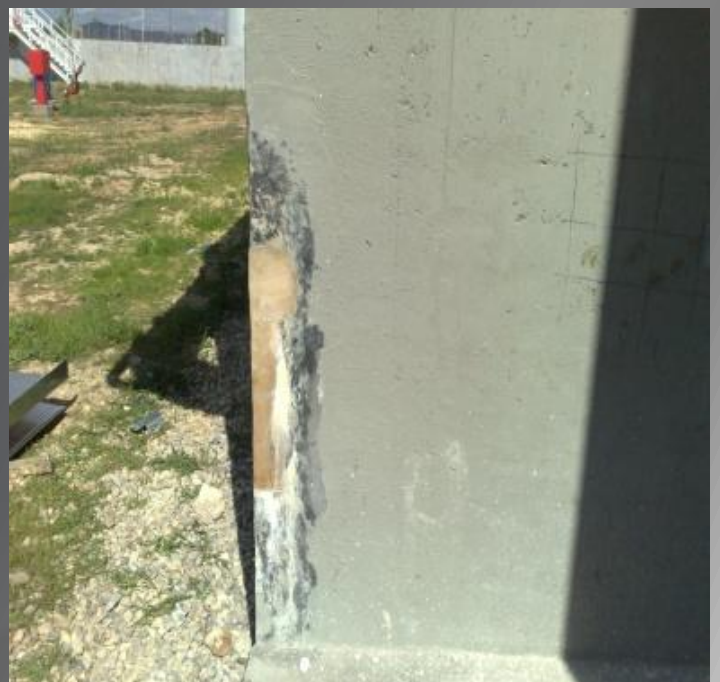
1º. Pathologies analysis. Study of the structure and parts, concrete composition, external degradative agents, characteristics of structures and surfaces, examination of the tank/decanter damages, exposure of the root causes of the degradation of surfaces: filtrations and defects of concrete and metal.

3º. Pretreatment. Part of the surface and inner structure of concrete reinforced by resin injection. fighting structural weaknesses found.

4º. Removing old coatings. With the structurally repaired surface, we proceed to remove the old coatings:

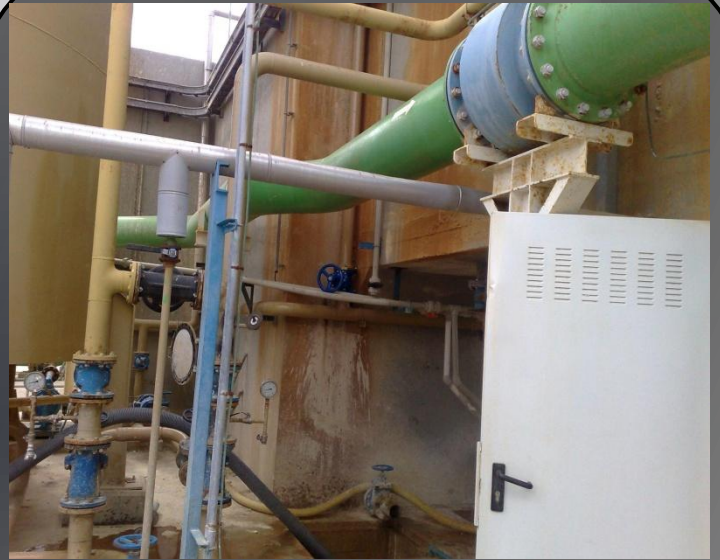
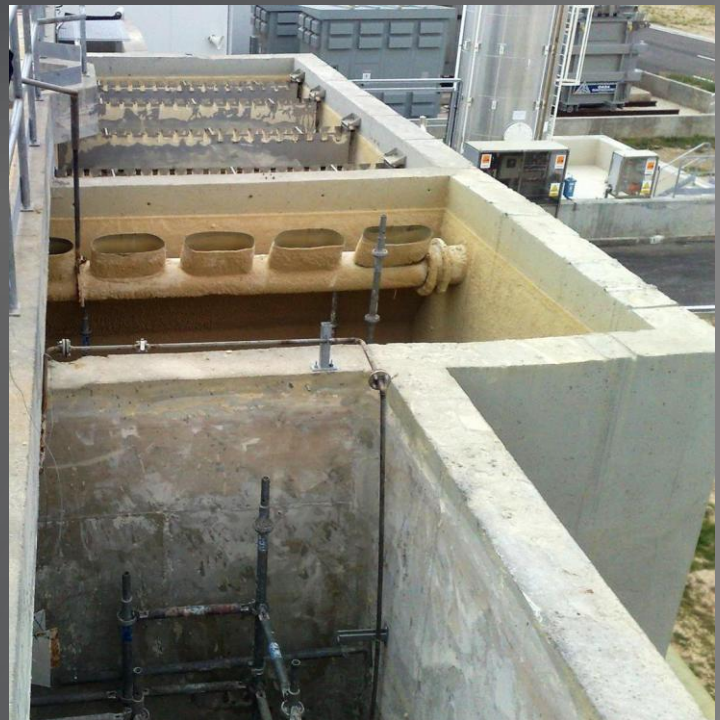
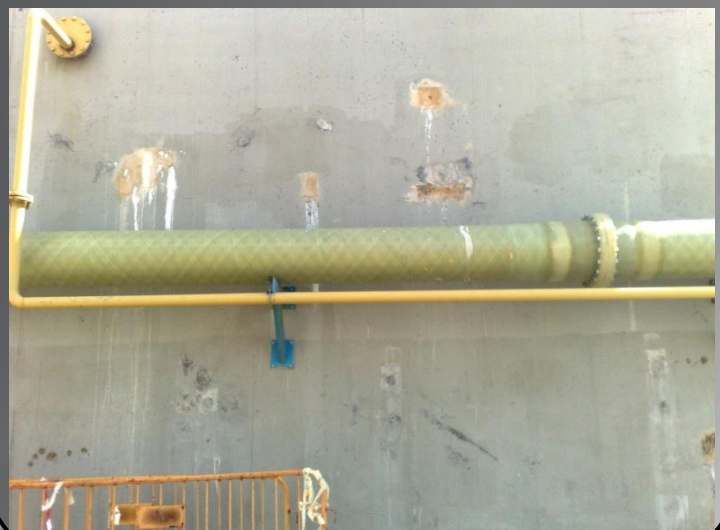
- From the interior of decanter: These coatings were not prepared to provide a quality sealing stability inside the decanter, so it was necessary its complete elimination.

- Of metal mechanical parts inside the decanter: The old coatings did not confer protection required depending on parts and mechanical wear to which they are subjected with regular use.

- From outside of the decanter: outside old coatings are completely eliminated given their ineffectiveness for external protection of concrete walls.

5°. Sanitation. Elimination of detached concrete surfaces. Cleaning, healing and protecting the exposed armors.

Reparations with special mortars for the filling of the surface part of the concrete structure.

Removing rust / corrosion and repairing the structures degradations and metal mechanical parts inside the decanter with ceramic-metallic systems.
