# G. N. F. COMBINED CYCLE POWER PLANT

Anticorrosive System

Combined cycle power plant of  
Aceca – Toledo – Spain

April 2009

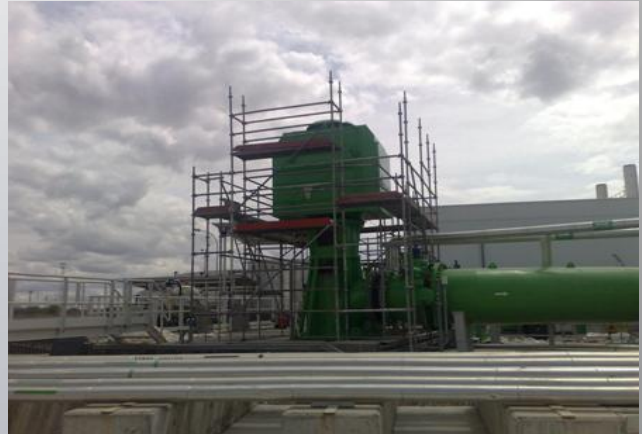
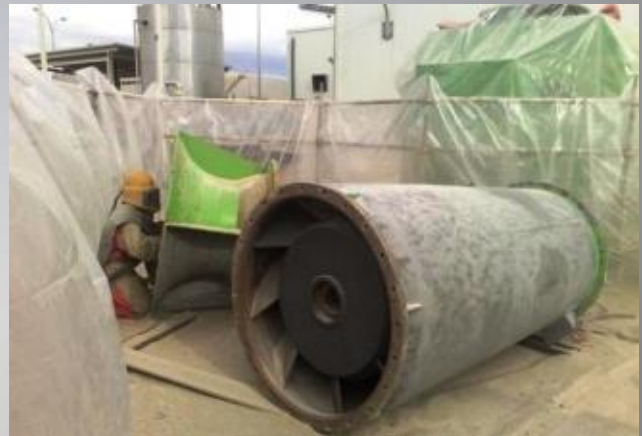
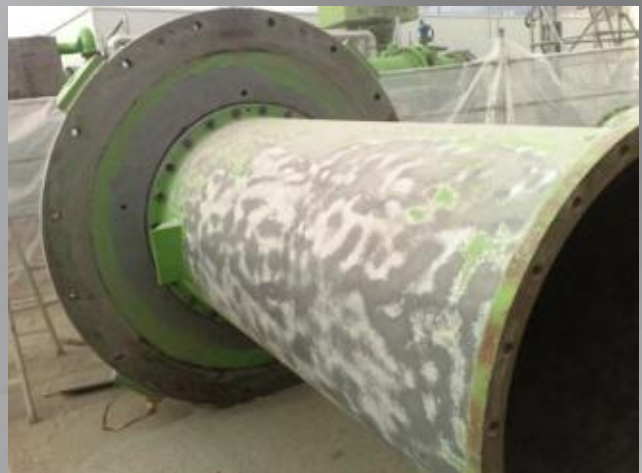
Mechanical parts with obvious  
problems:

- Corrosion,
- Deterioration of old coatings,
- Damage to the section of  
the metal.

Corrosion caused by water at  
various levels of pH and solids  
driven by water.

1º. Previous study of the  
corrosion generating agents and  
of old coatings used by "Gas  
Natural Fenosa" without  
success.

2º. Report and technical advice  
on the advanced systems  
recommended to protect  
mechanical parts against  
corrosion and erosion.
