REHABILITATION OF GUTTER WITH **MTS** BY UPPER FACE.

1/ GUTTER REHABILITATION.

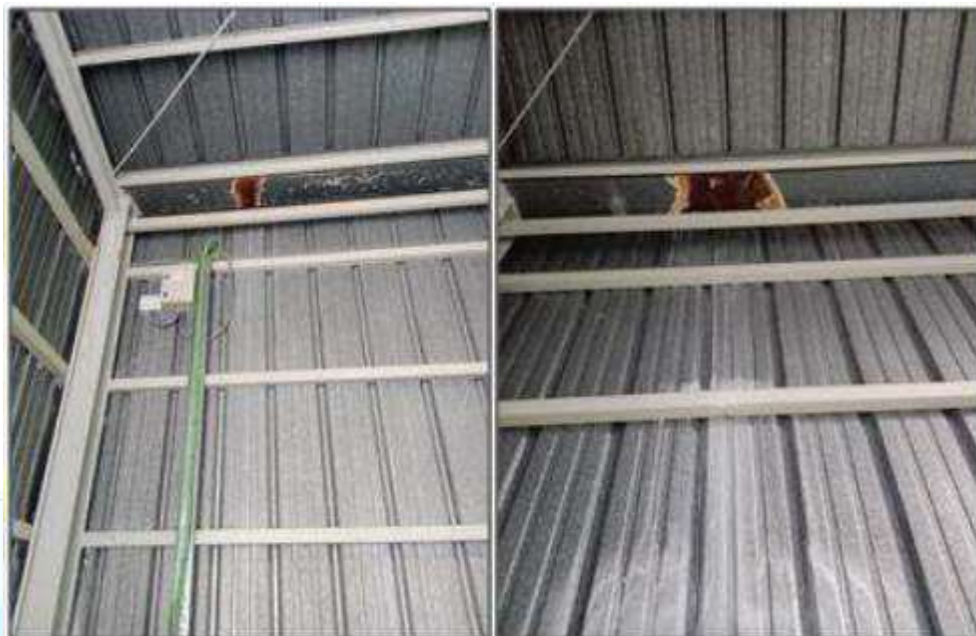
Gutters had substantial corrosion due to exposure to the weather, the problem was compounded by the loss of section producing leaks into the building (as seen in the initial images before processing) where they were located, water fell over electronic equipment causing damage to them.

Detail spouts corrosion and loss of section that caused leaks.

The ideal solution was the creation of a new surface by upper face, without joints or joints with **MTS** protecting these and completely stopping the process of degradation and corrosion, manufacturing a new plastic gutter with the same dimensions as the existing, eliminating the occurrence of leakage and therefore provides greater resistance.

After cleaning and surface preparation, the actions for the production began with **Mansillas Thermoplastic System (MTS)** new guttering.

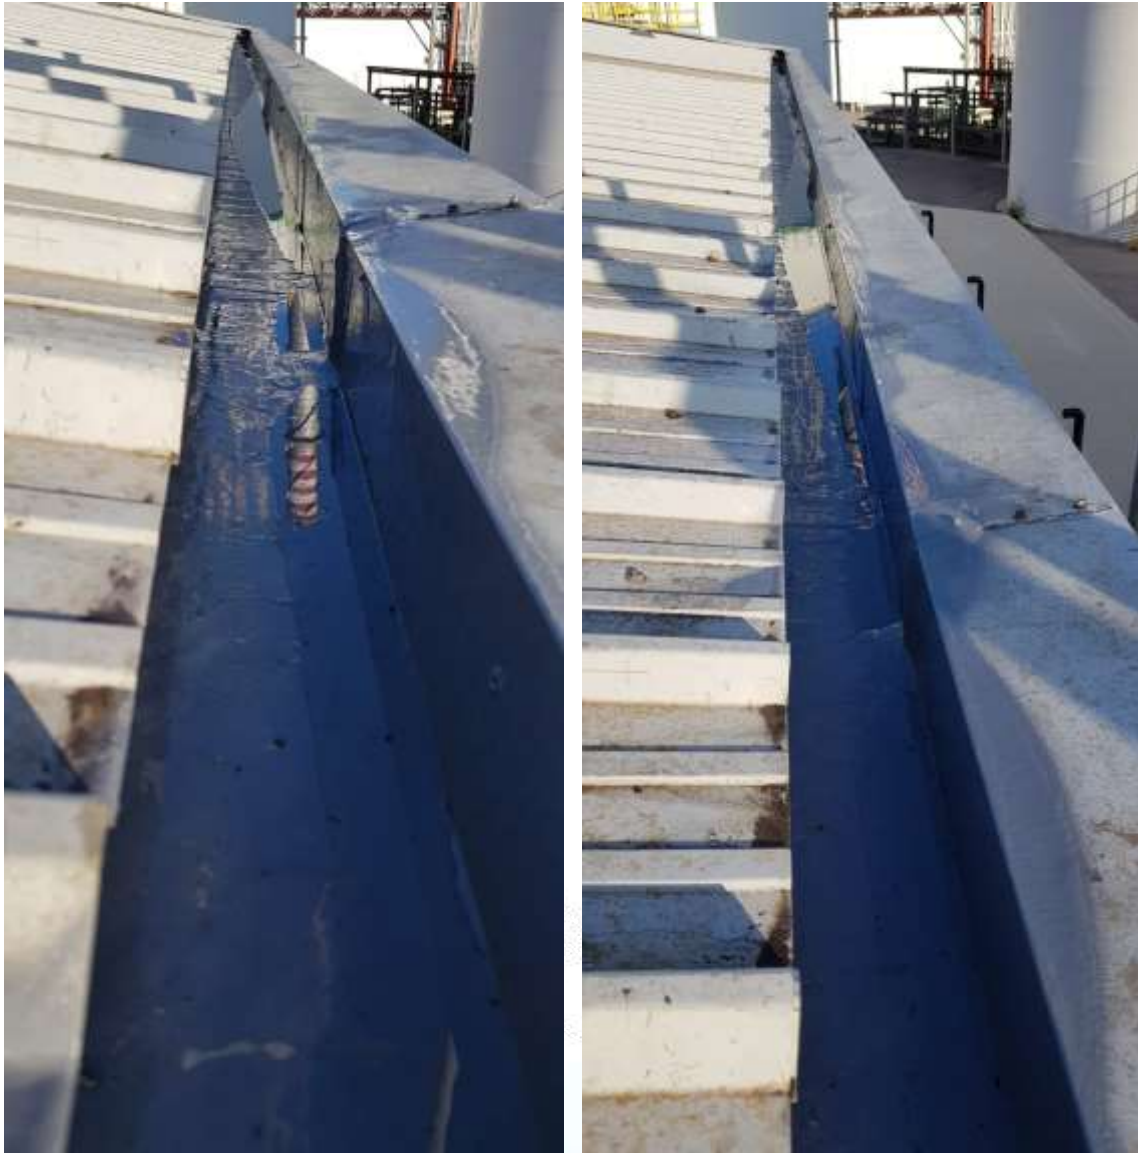
Gutters images after implantation of the MTS

Manufacturing execution new guttering, from cleaning up its implementation lasted about a week, because of their limited time curing facilities to be operational again quickly if the company cause serious disorders.

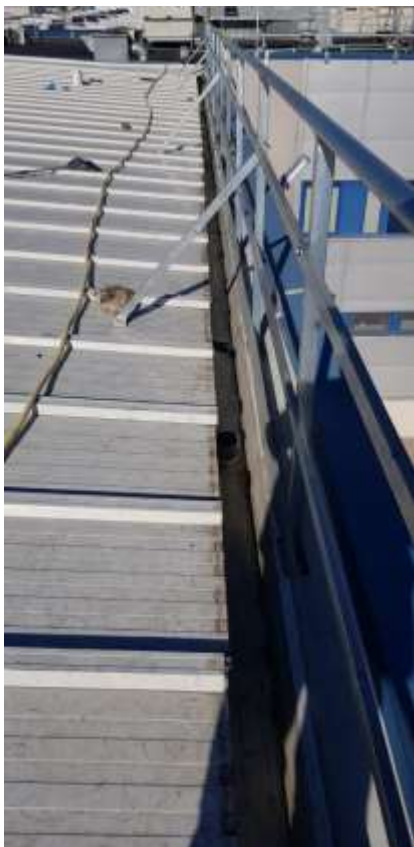
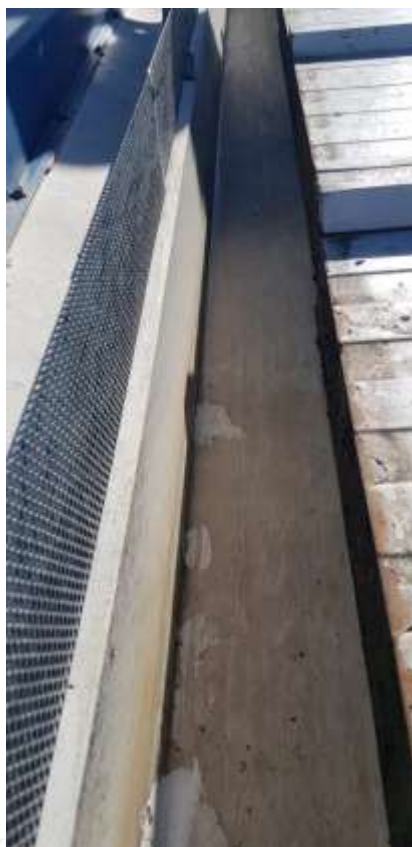
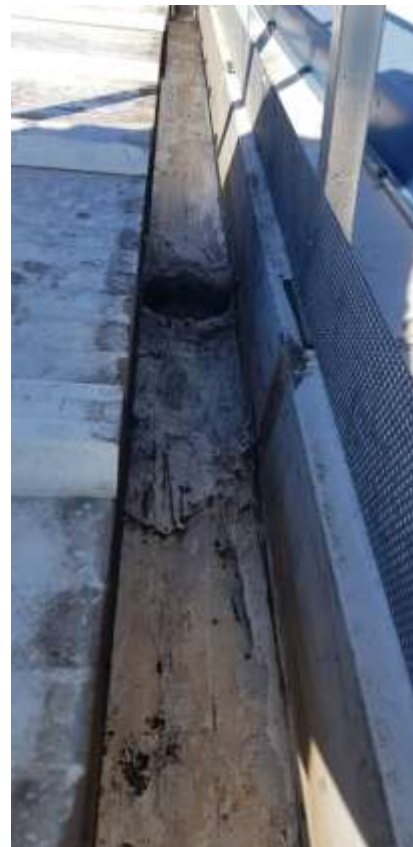
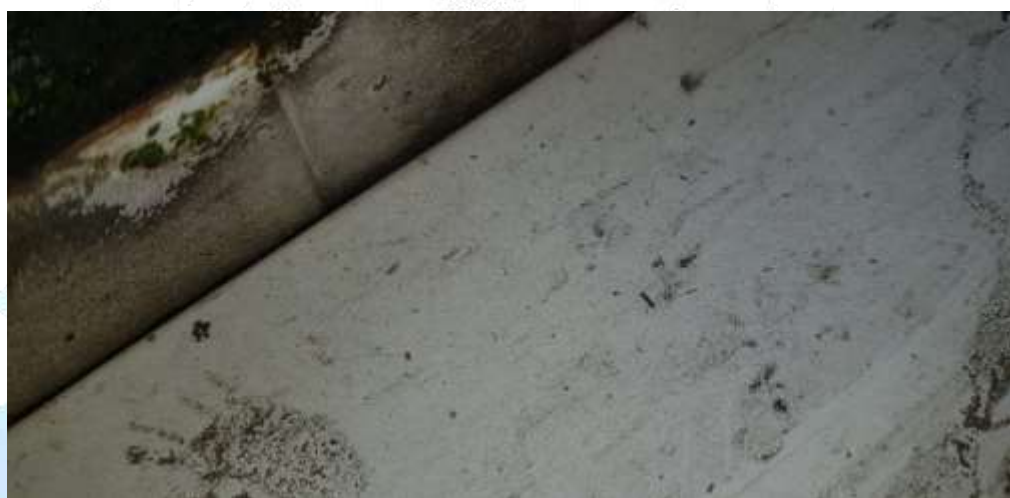
Initial state of gutters with the sándwich panel:

As in the previous gutter repair work, these were also metallic, they had corrosion and section losses, for this case, in addition to the waterproofing of the gutters, we included the waterproofing of the sándwich panel encounter with these gutters, to make a cover completely watertight, before the Works, large amount of water had entered inside due the damage of gutters.

The previous step to the manufacture of the new gutters with the sándwich panel encounter was the cleaning of the facility, preparing the surface for the primer applications, to finally manufacture the news gutters and the sándwich panel encounter with our **Mansillas Thermoplastic System (MTS)**, creating new continuous gutters and the sándwich panel encounter, avoiding the entrance of water inside.

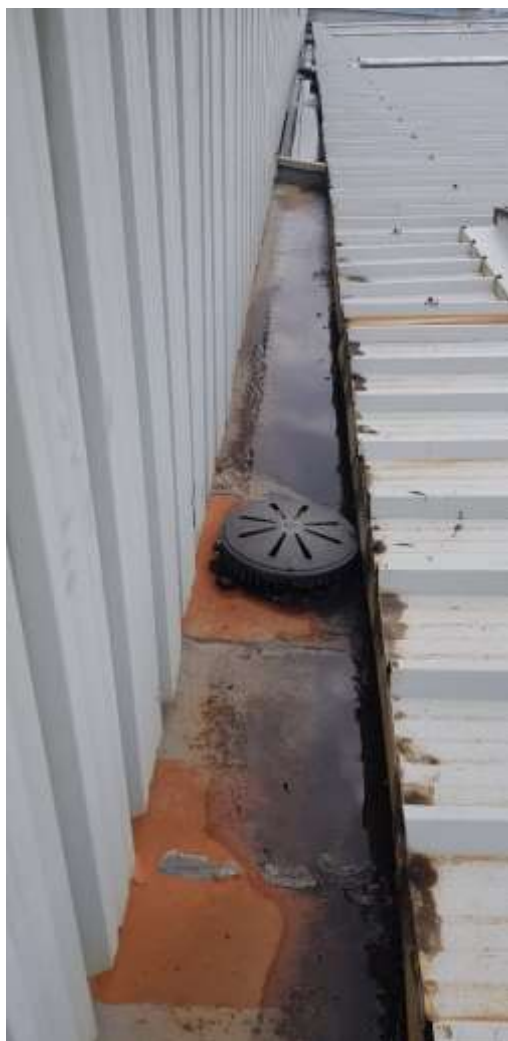
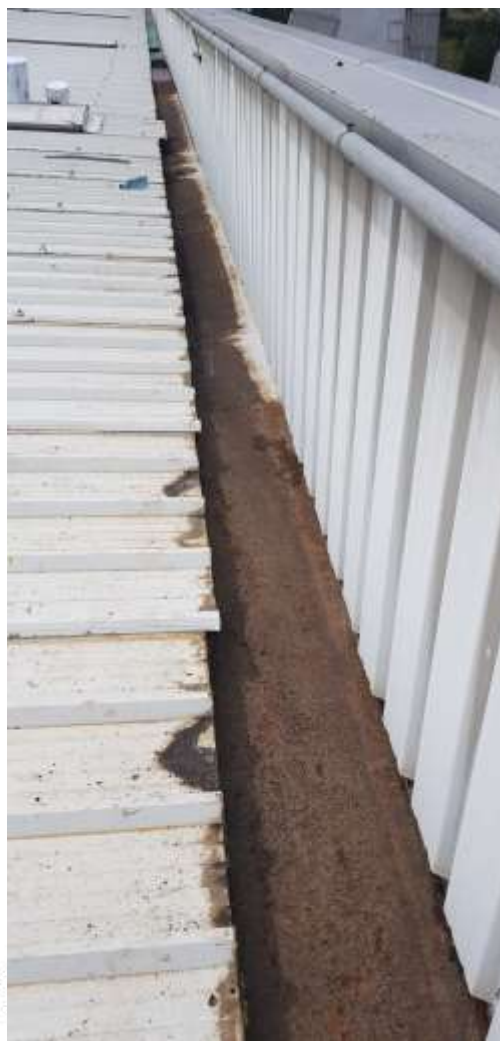
For this new work, the metallic linear gutter had quite severe corrosion as can be seen in the images prior to treatment with our **MTS**. If it had not stopped it, it would have caused the loss of the gutter section, causing water leaks in to the industrial unit.

Previously to the manufacture of the new gutter with **MTS**, the corrosion has been completely eliminated by mechanical tools (as electrical sander/grinder) to then apply the primer and leave the surface ready for the **MTS**.

After cleaning and subsequent application of the primer, a new linear gutter has been manufactured with our **Mansillas Thermoplastic System (MTS)** continuous, in one piece and totally waterproof, also stopping the degradation process caused by the severe corrosion that has the linear gutter.

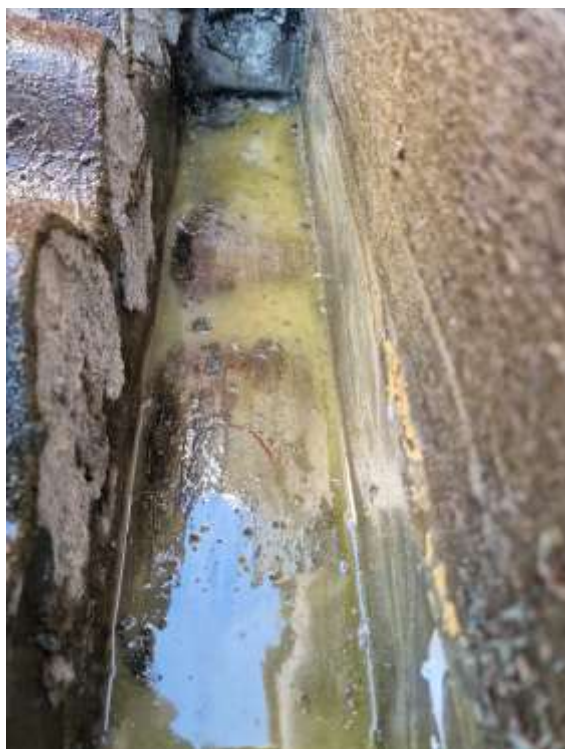
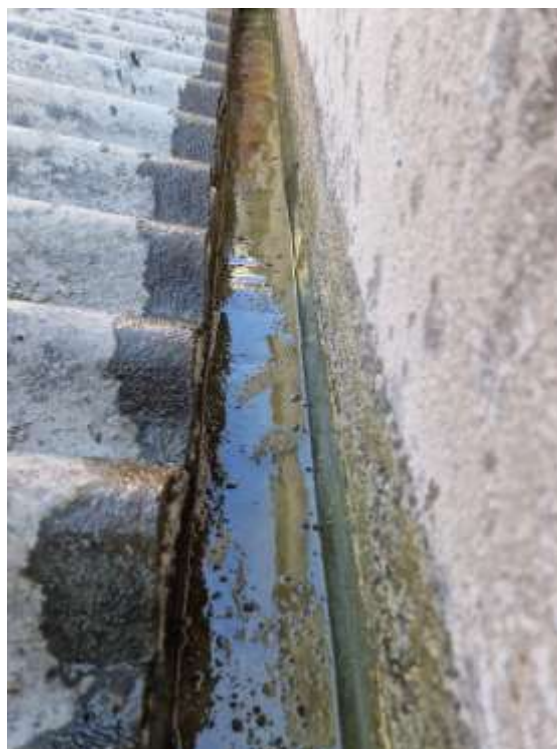
In this case, it is about fiber cement gutters, which, as can be seen during a visit prior to the work, are quite deteriorated, have had a Paint-type coating, with which the exposure to the weather conditions and the passage of time has been raising, exposing the fiber cement, which was also deteriorating, and if not stopped, could cause leaks inside the warehouse, the take advantage of the work to fix the holes in the fiber cement sheet that they have on this roof.

Prior to manufacturing the new fiber cement gutter with **MTS**, all the poorly adhered and detached old coating has been completely removed by mechanical means (with an electric sander/grinder) to then, apply a primer to decontaminate the surface, leaving it ready for the **MTS**.

After cleaning and subsequent application of the primer, a new gutter has been manufactured with our **Mansillas Thermoplastic System (MTS)**, continuous, in one piece and totally waterproof, protecting the fiber cement gutter and also stopping its deterioration.
