CITY OF ARTS - VALENCIA

Reparation and protection of the metallic structure of the rainwater collection tank (see underlined with a yellow circle in the upper right area of photo).

Ciudad de las Artes – Valencia – Spain

FINALIZATION: July 2008

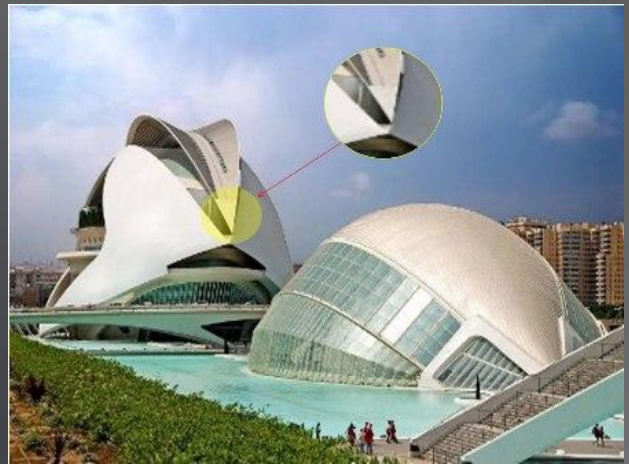
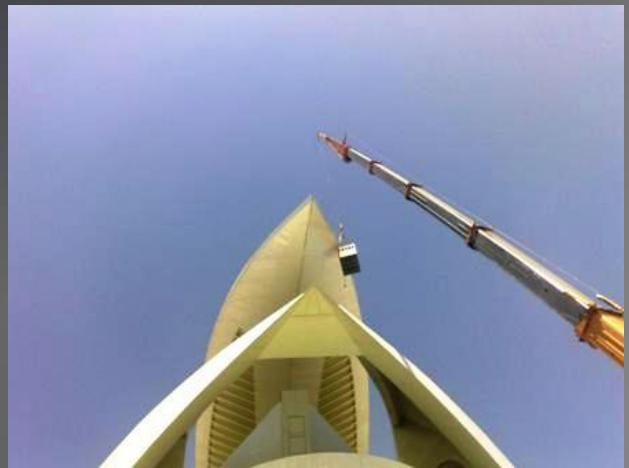
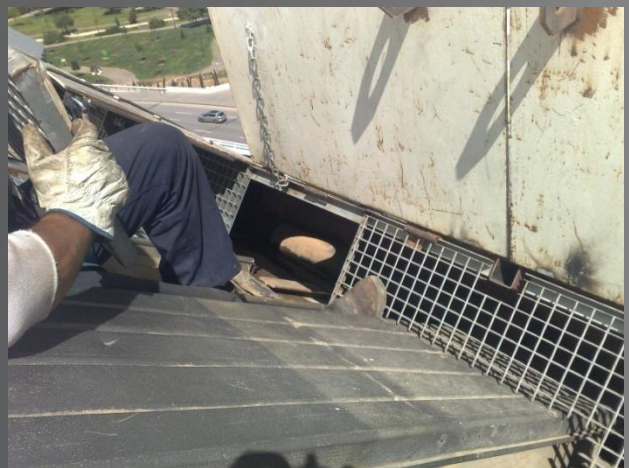
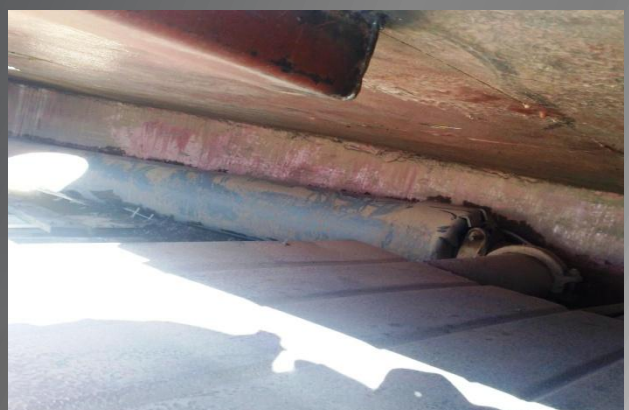
Corrosion problems and holes in the metallic rainwater collection tank. Tank is on top of the cover at a height of 99 meters.

Presence of water leaks through the damaged structure causing corrosion problems in other areas of the outer armature of the architectural structure.

Repairing and protecting inside the tank channeling rainwater from the roof. Previous we prepared the surface by eliminating corrosion and contaminants. Thereafter we repaired perforations by using a ceramic and metallic system for covering damaged areas and low sections.

Finally we manufactured a new deposit inside the existing tank by employing advanced coatings, resulting in a jacketed plastic tank resistant to corrosion and having high performance against weathering.

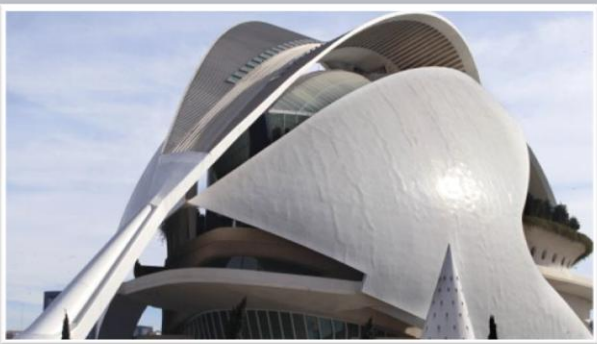
Picture: Newspaper El Pais. Valencia.

Currently this architectural building has serious problems and deficiencies of the cover (lost of 60% of the surface of the cover, with water inlets and steel oxidation) caused by the design (lack of expansion joints) and the selection of materials used in its construction (the inconsistency in the ratio of expansion of steel sheets and ceramic trencadis - a type of mosaic-).
