THE CENTRAL AMOREBIETA

Protection and rehabilitation of concrete structures and pavements.

Combined cycle power plant of Bizkaia Energía – Amorebieta –Spain.

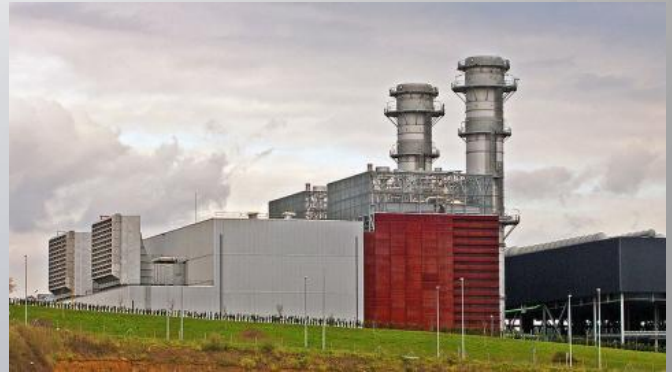
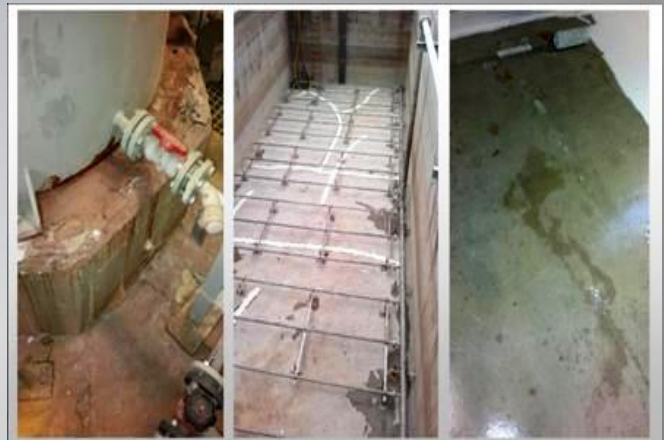
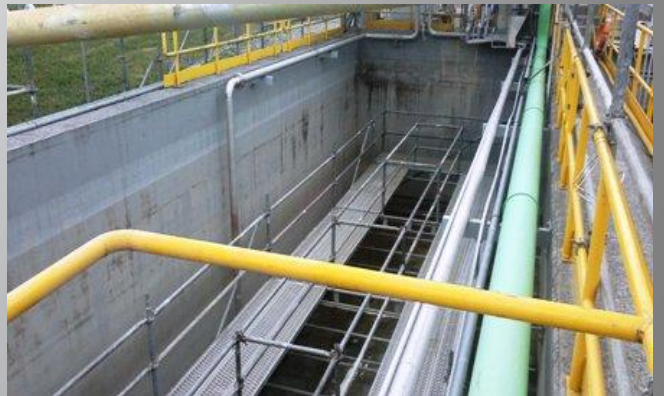
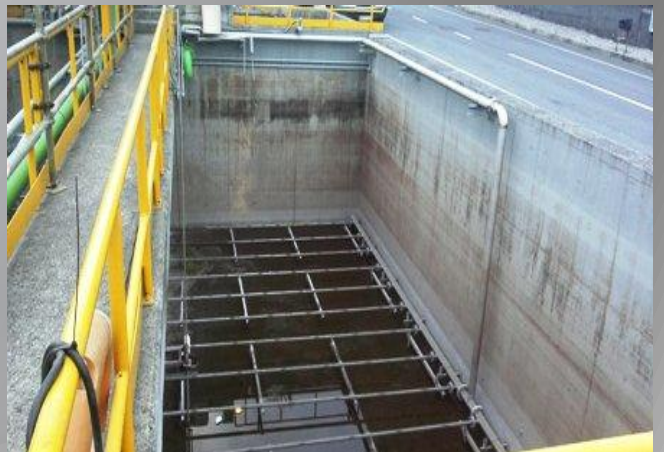
Holding tanks, metallic elements and deteriorated concrete of industrial flooring, with leaks and cracks and detachments or losses section.

Prior review of the facilities and damaged structures.

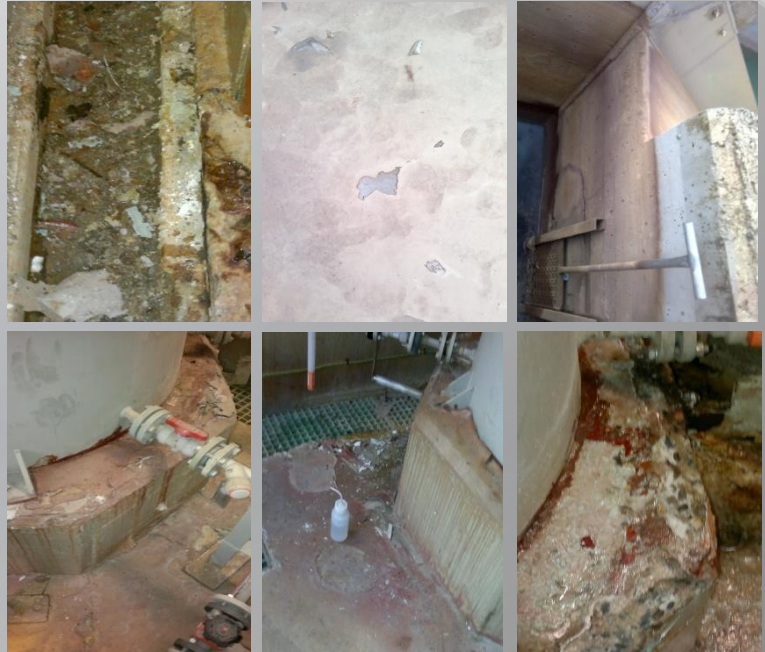
Thorough cleaning of contaminants / residues and removal of old and badly adhered coatings.

Cleaning with mechanical and manual means and use of chemicals, abrasives and pressurized water, depending on areas and characteristics of dirt or coating to remove.

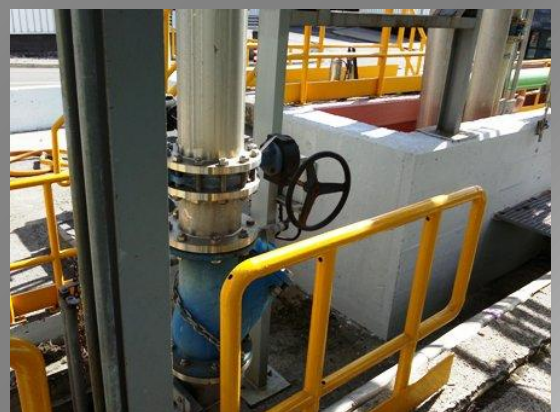
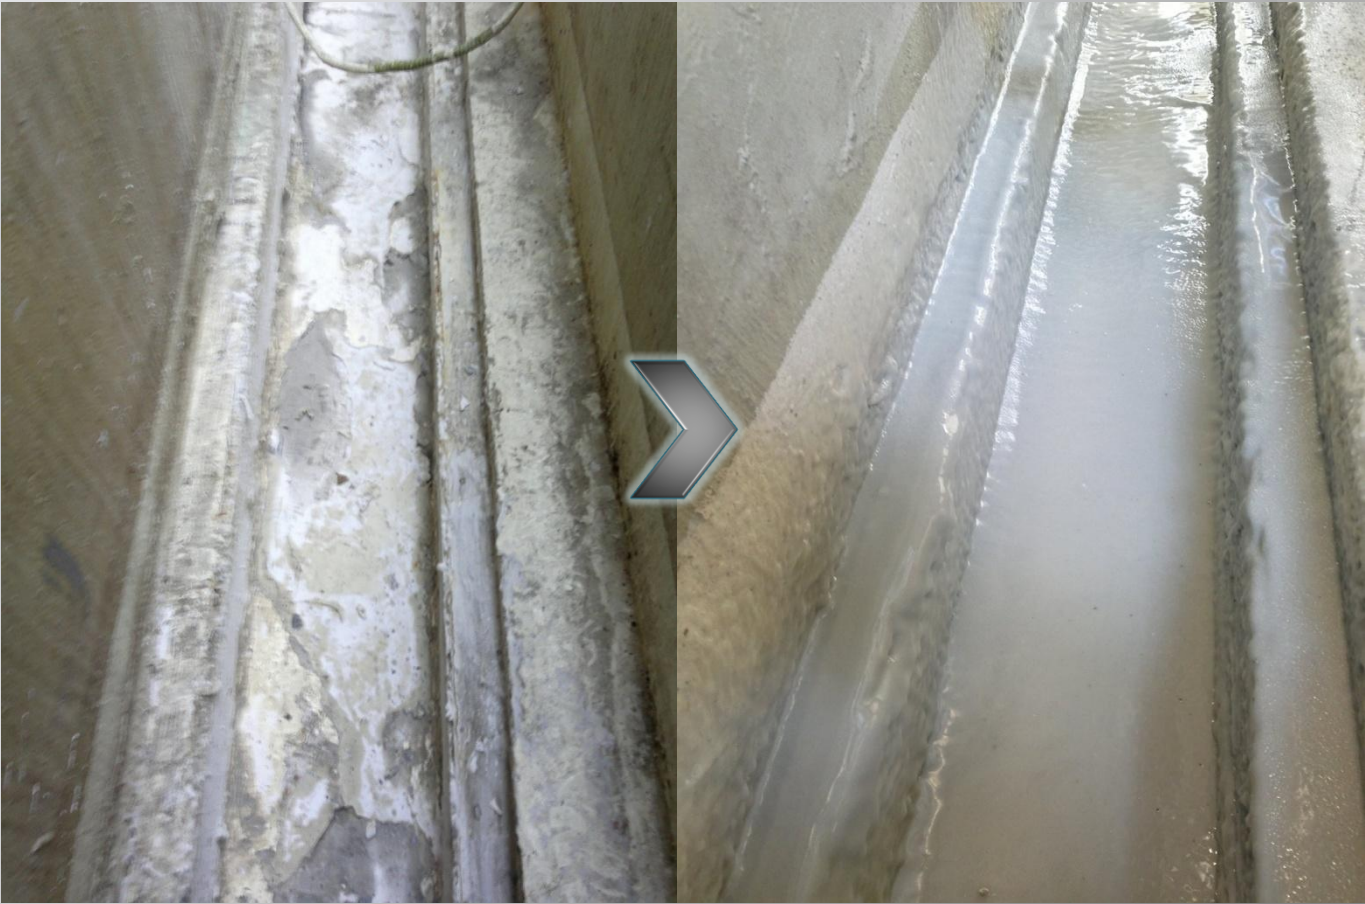
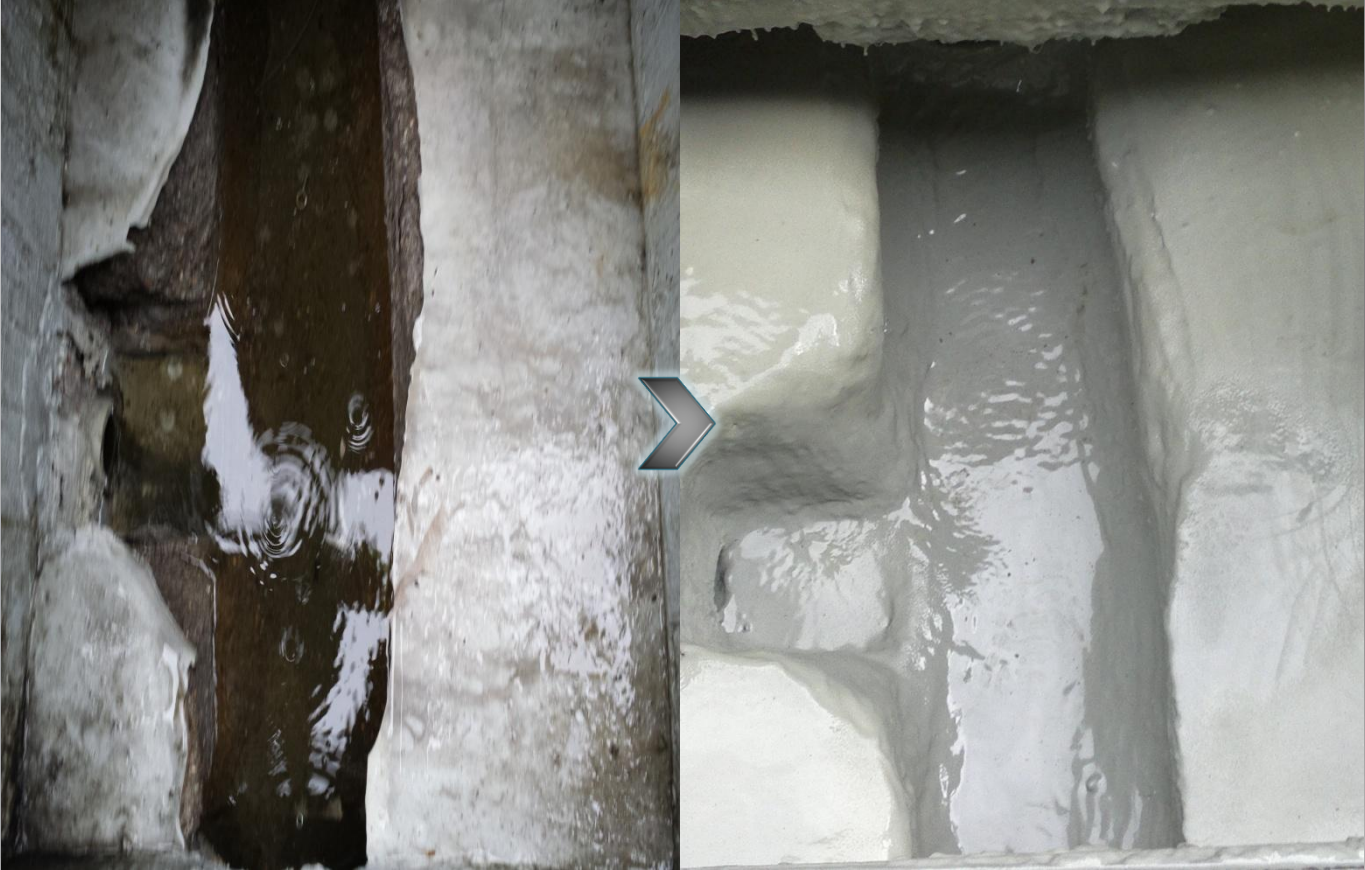
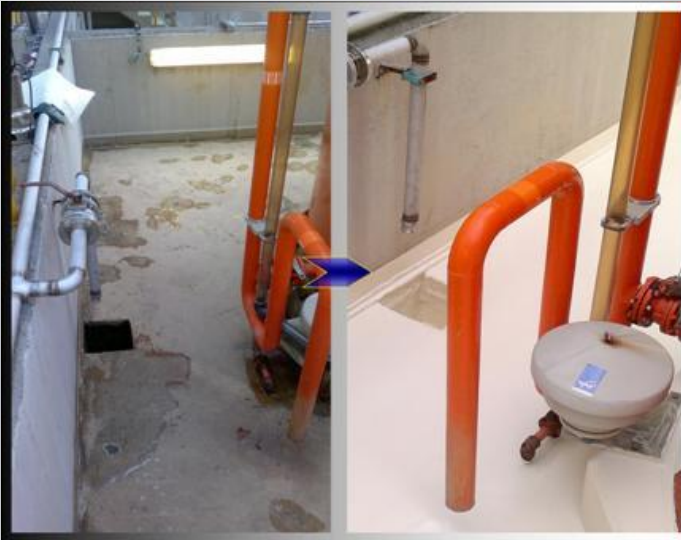
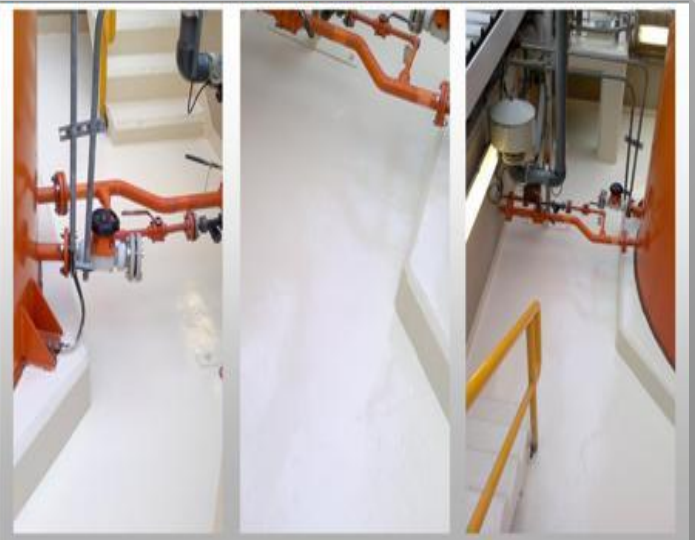
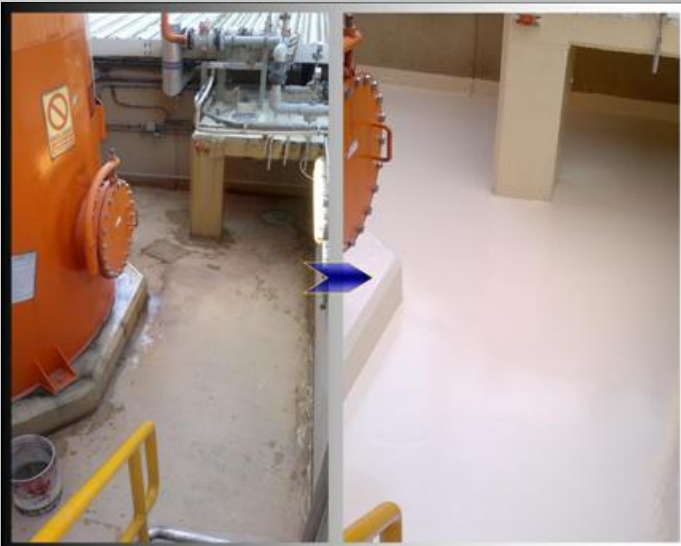
Protection of the various surfaces repaired with the advanced coating systems. See below pictures of rehabilitated and protected areas: concrete ponds, holding tanks, metallic elements and industrial flooring.

Repair leaks, cracks, section loss and deteriorated structures by: resin injection and fluid mortar for concrete surfaces and recomposition of metallic elements with ceramic-metal systems.
