CABLE-STAYED BRIDGE TALAVERA DE LA REINA (TOLEDO)

Reparation and corrosion protection of cables tighteners of suspension bridge. Key parts for the proper maintenance of the cable-stayed bridge; if those parts lose structural density it will seriously compromise the stability of the bridge, still remain paramount protection. Including anti-vandal protection, as the tighteners are exposed to vandalism because of the access to the pedestrian and foot traffic.

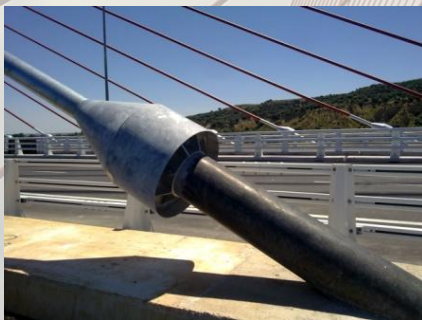
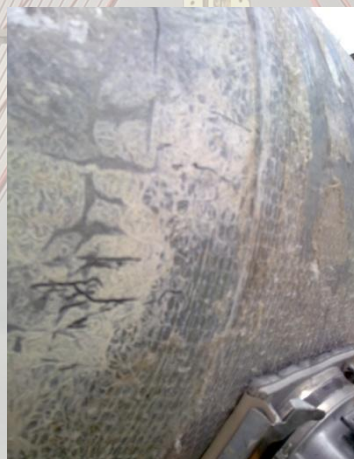
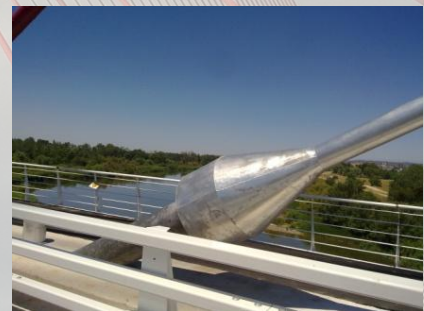
The examined surface showed white rust and saltpeter on galvanization, due to bad curing of galvanization, anti-vandal and imperfections caused by the action of oxygen with a bad curing of the galvanized protection while application.

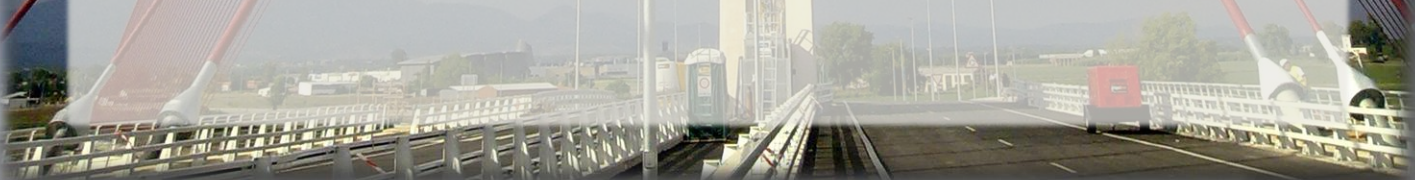
For correct protection and knowing that the structure is located in an environment with high humidity (freshwater environment), we make the following corrosion protection system:

ANTICORROSIVE SYSTEM

It consist in the elimination of corrosion, by applying an aluminum coating for reinforcing metallic structure against corrosion and finalizing with a protection of the metal coating with an advanced coatings resistant to vandalism impacts.

1º. Surface Preparation: Remove white corrosion.

Elimination of corrosion of the metal surfaces of the anti-vandal protection and guide tubes that protect tensors of cables of the suspension bridge, by mechanical sanding to remove saltpeter from the shabby galvanization, correcting imperfections formed by the presence of oxygen adjacently to the poorly cured galvanization.

2º. Metal coating of aluminum

Application of an aluminum metal coating specific for galvanized surfaces suitable for corrosive atmospheres. Providing an excellent bridge between the galvanized surface and the next phase of the system.

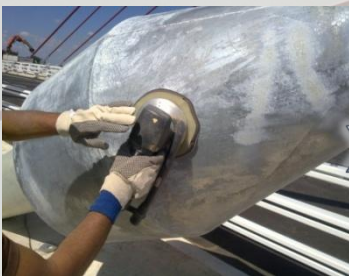
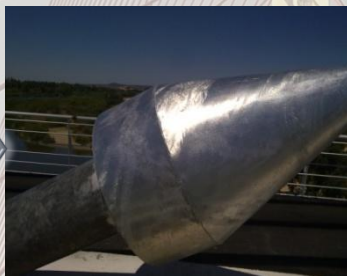
The surface required, as proper treatment, an exhaustive sanding to show a significant white corrosion of the galvanization as nitrate and oxide.

The metal parts were completely pure and prepared for subsequent phases of the anticorrosive system.

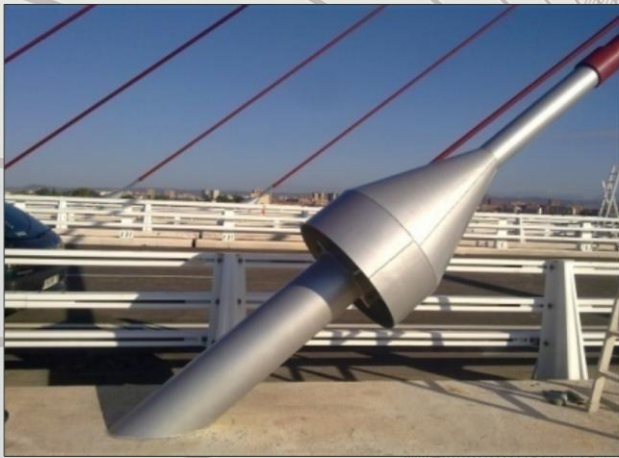
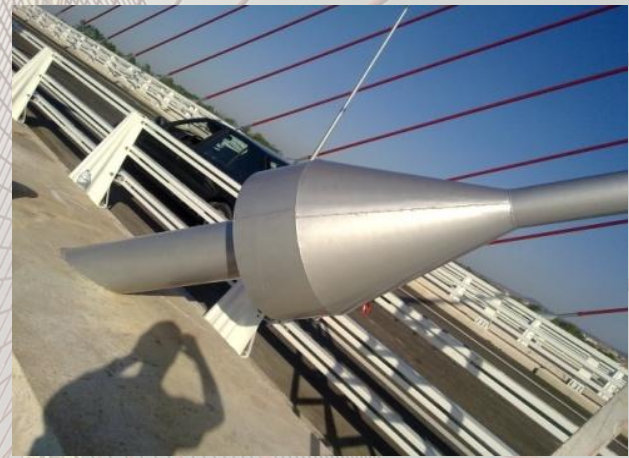
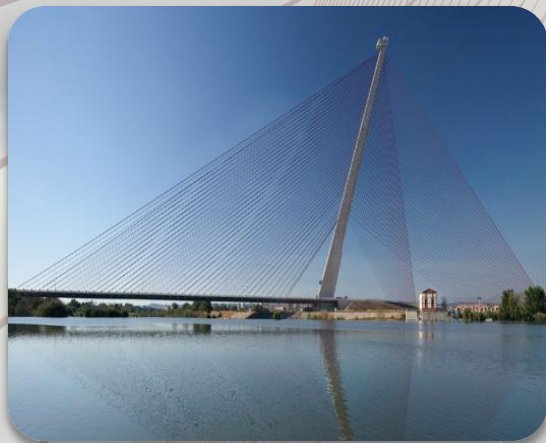
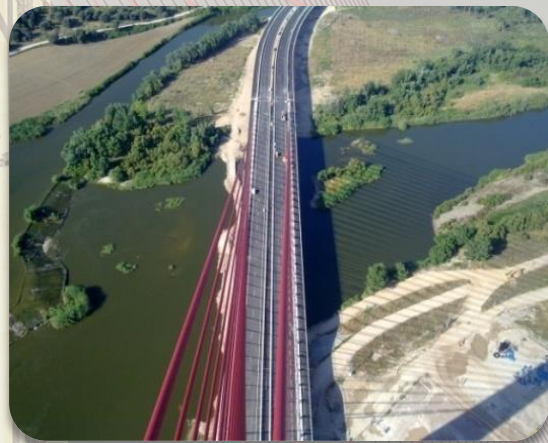
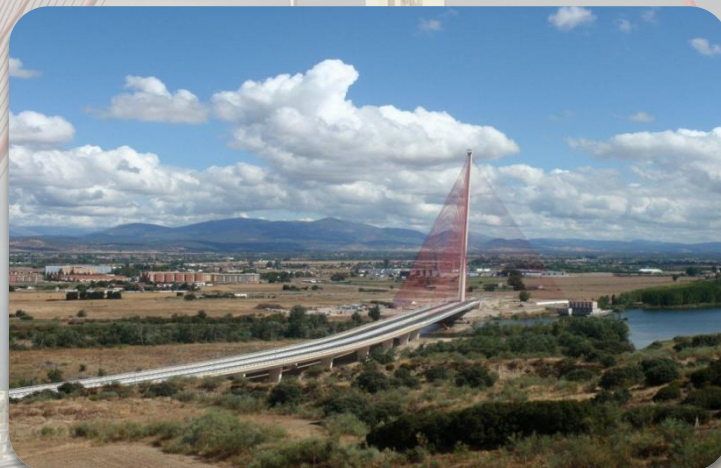
3º. Finishing: anticorrosive and protection against vandalism system with advanced coatings.

To provide the best anticorrosive and anti-vandal protection, given the importance of the structural function supported by the parts to protect, advanced coatings were employed getting a top quality finish in high humidity environments.
