MANUFACTURE OF **MTS** INSIDE TUNNEL CHAMBER.

INSIDE TUNNEL CHAMBER REHABILITATION

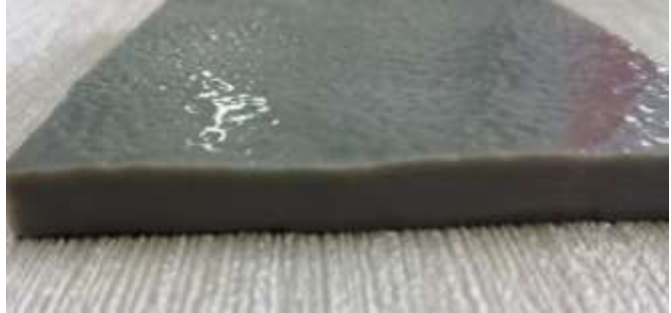
Sample of MTS used in tunnel chamber.

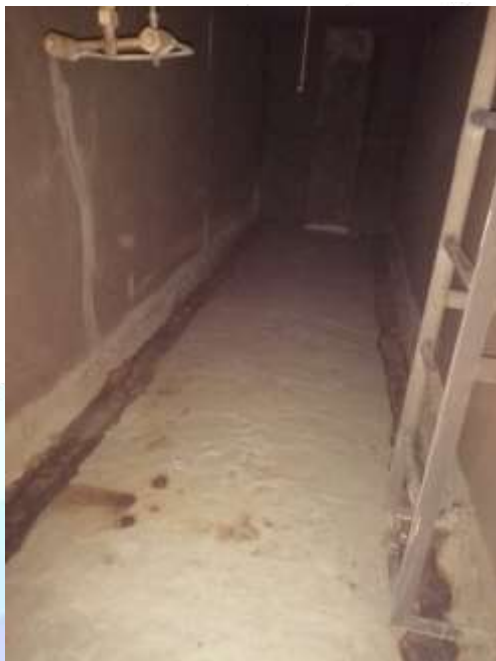
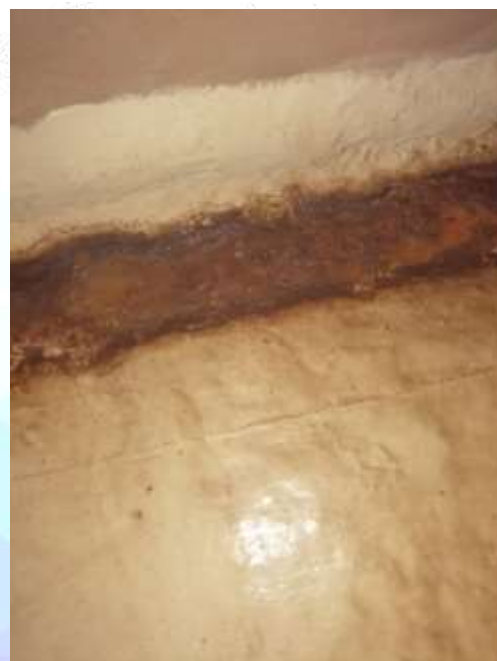
During a technical visit, a tunnel chamber was observed, whose interior base presents cracks and poor condition, it has lost its tightness, this chamber works with large thermal changes, with a temperature of 80° and a humidity of 100%, which causes expansions that could have cause these cracks and their deterioration..

The condition of the camera is as shown in the images below:

The ideal solution is the interior rehabilitation of the chamber tunnel, with ***Mansillas Thermoplastic System (MTS)***, thus slowing the degradation process of this structure, by protecting it from the humidity that circulates through its interior by creating a new base with STM in One piece and completely waterproof.

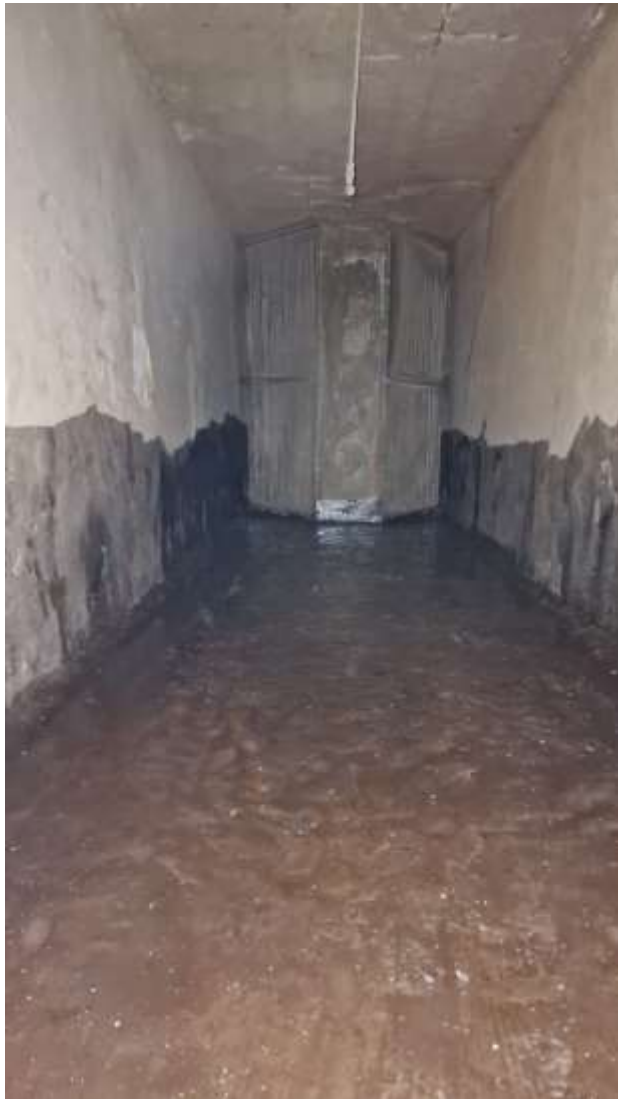
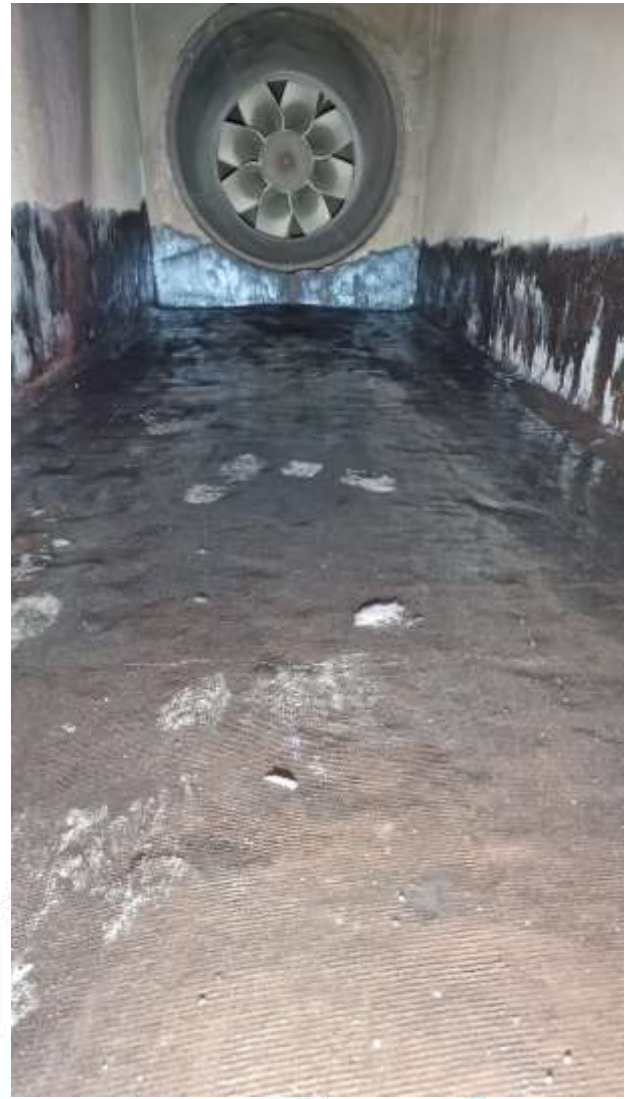
The first step has been to clean the corrosion that the chamber tunnel had, to later apply primer to decontaminate the surface and finally, manufacture the new base, continuously without joints and in a single piece with our ***Mansillas Thermoplastic System (MTS)***.

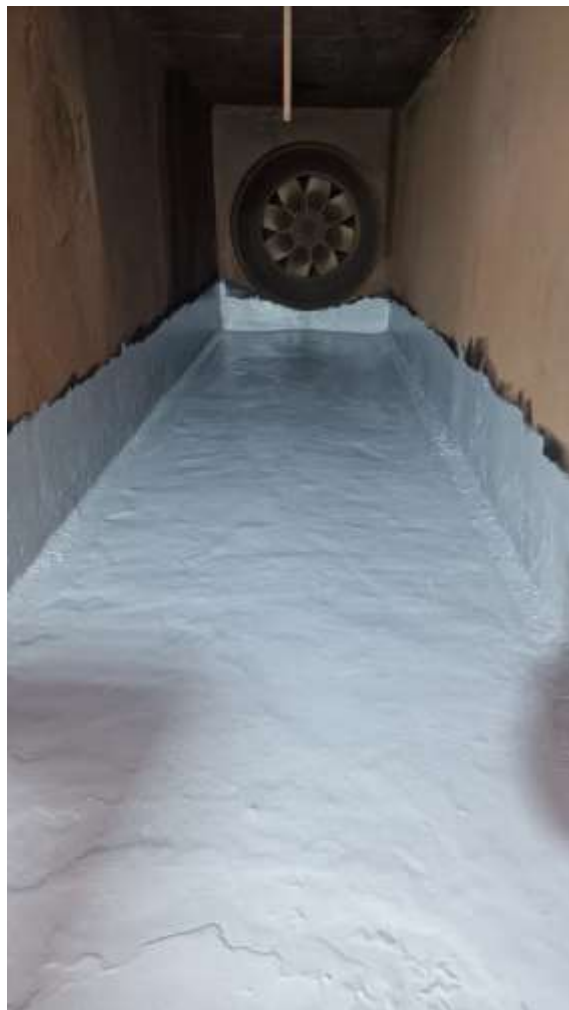
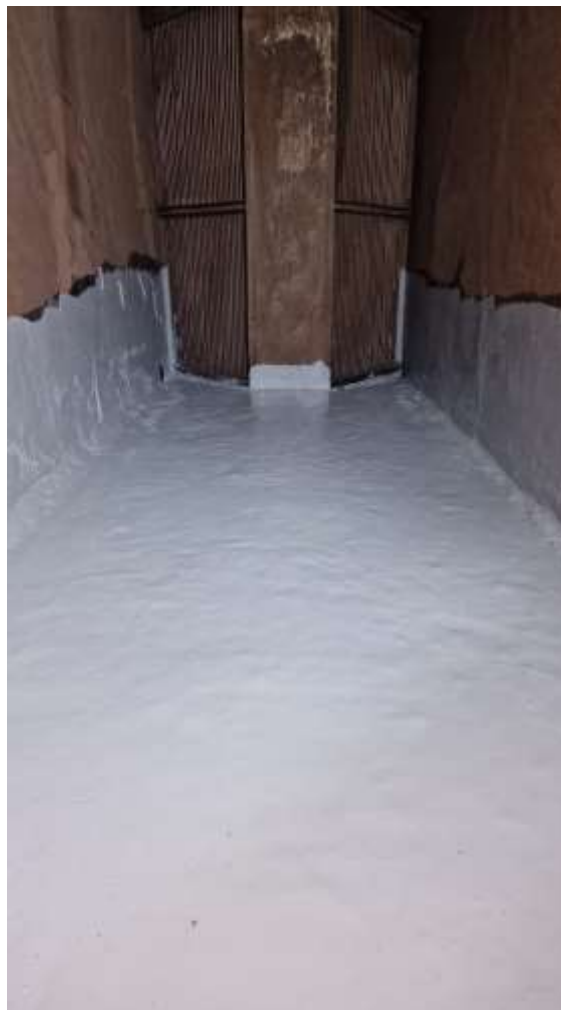
The result after the manufacture of the **MTS** is the next:

With Mansillas Themoplastic System (MTS) we have created a new base, with the same dimensions as the old ones, but with greater resistance and durability, also stopping its degradation.

The execution of the works, from cleaning the corrosion, to the manufacturing of the new tunnel base, lasted approximately three days, with the facilities being operational again in a short time.
